## **Ice-Affected Components of Locks and Dams**

Andrew M. Tuthill

February 2002

Technical Report  
ERDC/CRREL TR-02-4

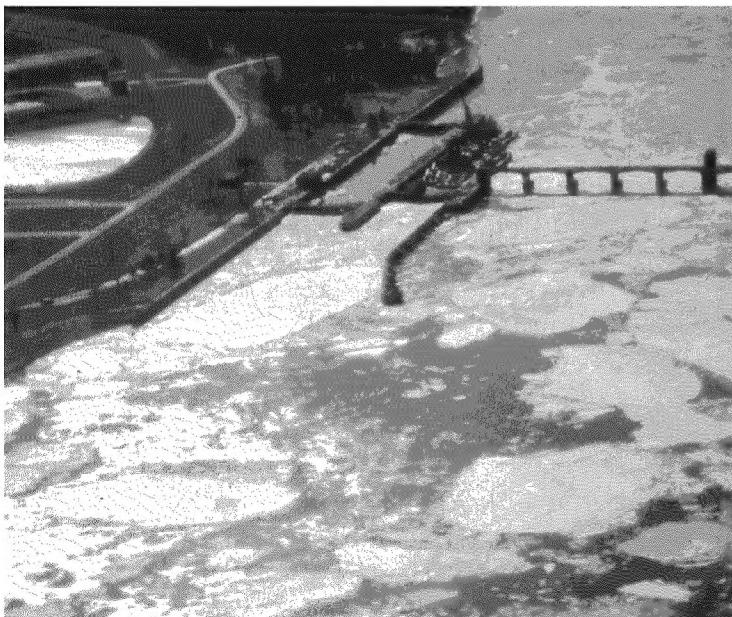
Ice congestion of the upper lock approach is one of the most common winter operation problems at Corps locks and it leads directly to many other lock ice problems, such as brash ice in the gate recesses and lock chamber (Fig. 3). The layout and plan area of the upper

**Figure 3. Ice accumulation in the upper approach at Lock and Dam 21 on the upper Mississippi River.**

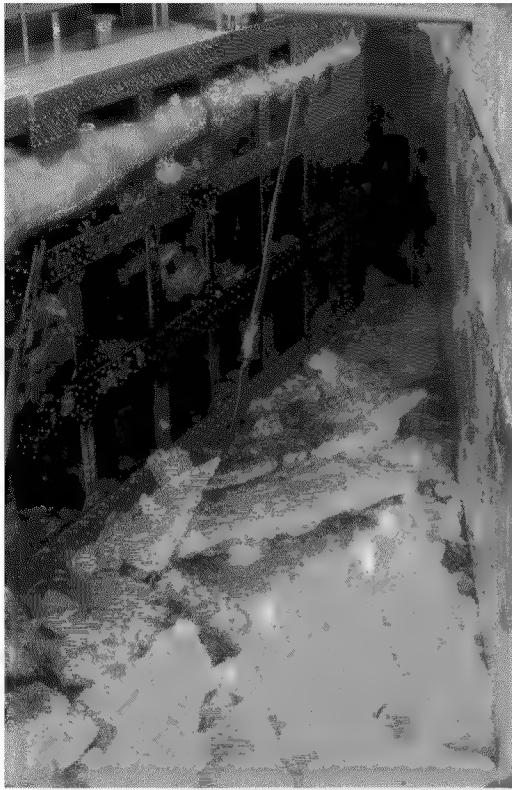
Brash in the miter gate recesses greatly hinders winter operation by preventing the miter gates from fully opening (Fig. 5). Once this situation begins to occur, the Corps may require the barge industry to limit the length and width of its tows, a measure that greatly reduces the cargo capacity of the waterway system. Locking tows in ice with partially opened miter gates is not

**Figure 5. Brash ice in the miter gate recess.**

Ice trapped between the back of the miter gate and the recess wall can damage the gate and over-stress the gate hinge mechanisms. Examples are dents in the steel skin plates on the backs of the miter gates at Starved Rock Lock on the Illinois Waterway and cracks in the welds on the old miter gates at Lock 20 on the upper Mississippi.‡ In the past, operators were limited to manually clearing brash ice from the recesses using pike

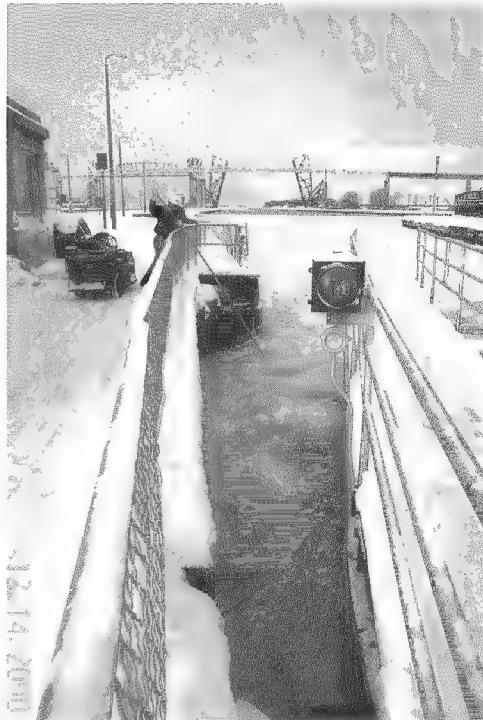
**Figure 6. Clearing brash ice from the gate recess with a pike pole at the Soo Locks.**

poles and ice rakes (Fig. 6). Another method at their disposal is to open the emptying valves with the chamber at high pool to draw the ice out of the miter gate recesses and into the chamber. Closing the emptying valves then creates a “backwash” effect and a temporary upstream current that also helps clear the ice from the recess area. Operators also swing the miter gates back and forth or “fan the gates” in an effort to force the ice out of the recess. Many believe that gate fanning causes premature wear and tear on gate support systems and operating machinery. High-flow air bubblers, termed “recess flushers,” described in “Bubbler systems” have greatly alleviated the problem of brash ice in the gate recesses.

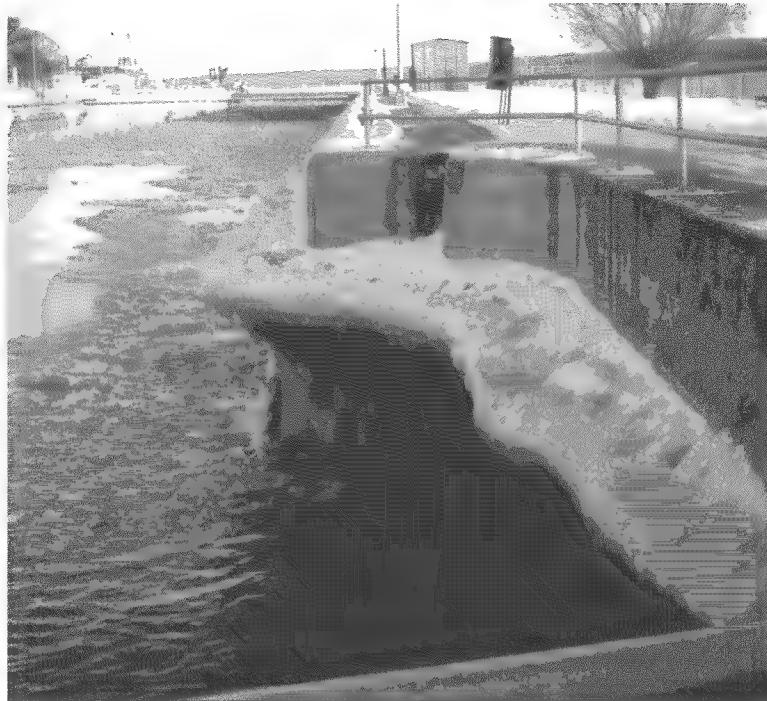
**Figure 7. Ice collars in the gate recess and on the lock wall.**

Lock walls, like the gate recesses, are extremely susceptible to icing and the formation of ice collars. With repeated wetting from the lowering and raising of the chamber, the ice adheres extremely well to the worn concrete and steel rub plates typical of many Corps locks. The thickest buildups typically form at the high pool level and can achieve widths of greater than 3 ft, preventing 105-ft-wide tows or vessels from entering 110-ft-wide locks (Fig. 7). Typically, lock wall icing is more severe on north-facing than south-facing walls due to the beneficial effect of solar radiation. Some believe that ice collar formation can be reduced by keeping the chamber at high pool when not in use.\* A possible explanation is that, at high pool, most of the wall area is submerged and therefore protected from sub-freezing air temperature.

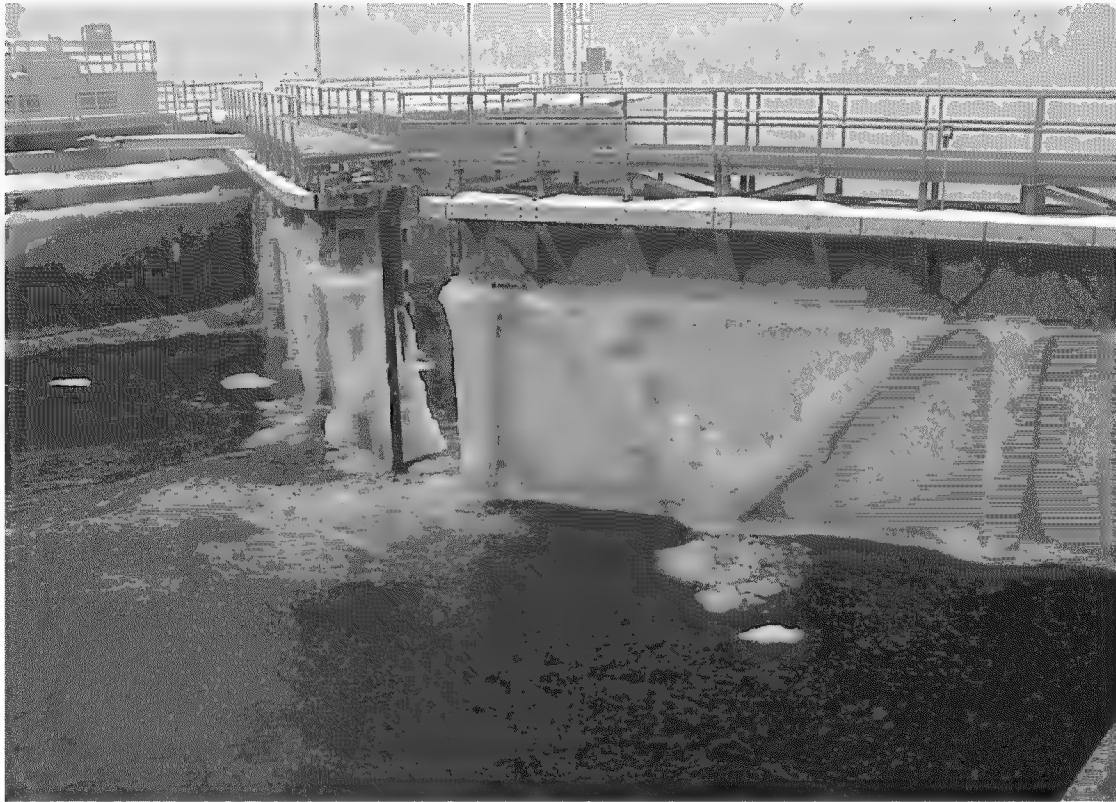
**Figure 10. Miter at Lock 24 on the upper Mississippi with widely spaced structural members on the upstream side.**

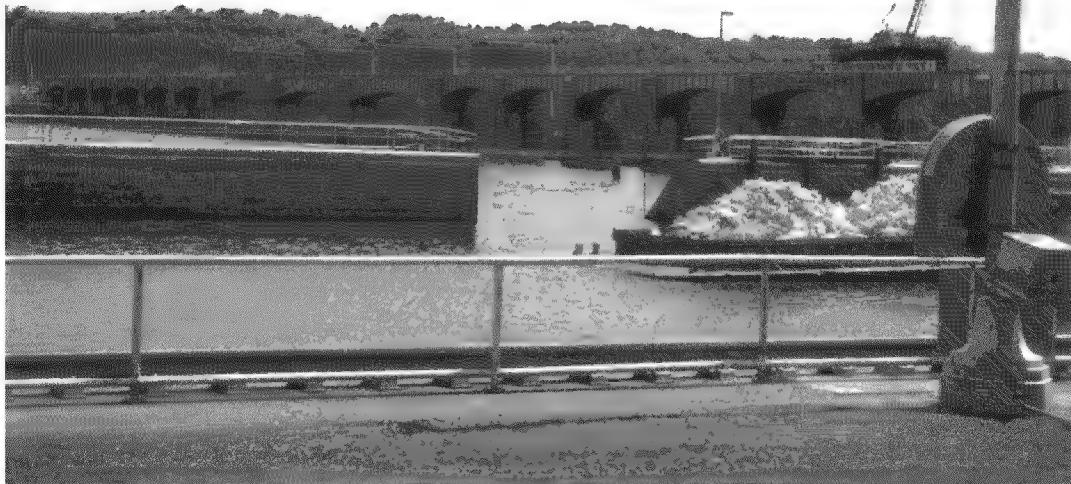
**Figure 13. Drift pass in the river guardwall being widened at Lock and Dam 25 on the upper Mississippi.**

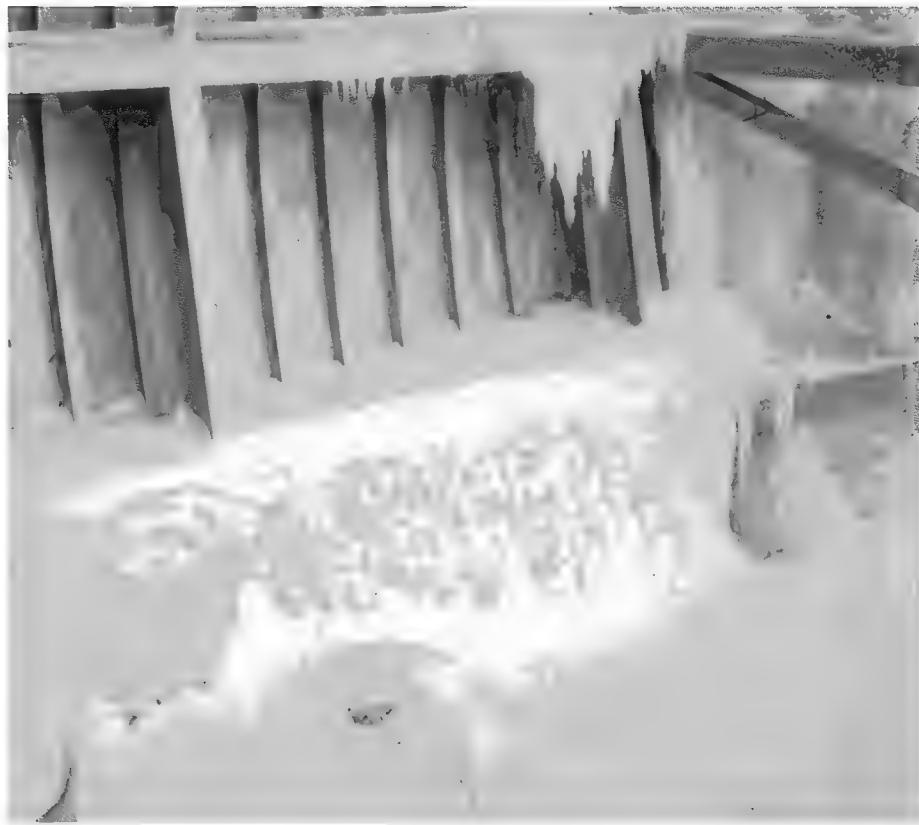
Tainter gate trunnion arms often freeze to adjacent pier walls as a result of spray icing and side seal leakage (Fig. 19). The clearance between the gate arm and the wall influences the severity of the problem. For example, at Starved Rock and Dresden Island Dams on the Illinois River, the clearance is only a few inches and the gate arm freezing problem is severe. Marseilles Dam, which lies between Dresden and Starved Rock, was retrofitted in 1989 with submergible tainter gates with the trunnion arms angled away from the pier walls (Fig. 20). The greater side clearance largely eliminated the freezing-in problem. Also, during cold periods, the gates are operated in the submerged mode, which eliminates spray icing and side seal freezing. On the upper Mississippi, the clearance between gate arms and the pier walls is about six inches and freezing-in is typically less of a problem than on the older gates on the Illinois River.

**Figure 19. Iced-in tainter gate.**

Spray ice and seal leakage often lead to substantial ice buildups on gate structural members and trusswork (Fig. 19). In addition to freezing the gate in place, the weight of the accreted ice can overstress or exceed the capacity of the lifting mechanisms. Enclosing the gate trusswork with sheet metal reduces the ice buildup on gate structural components to some degree. At Starved Rock Dam two gates were enclosed and steam applied inside with only marginal ice-melting success.
